15 YEARS LATER: ON THE PHYSICS OF HIGH-RISE BUILDING COLLAPSES

■ Steven Jones¹, Robert Korol², Anthony Szamboti³ and Ted Walter⁴

■ ¹Brigham Young University (early retired) – ²McMaster University (emeritus) – ³Mechanical design engineer in the aerospace industry – ⁴Architects & Engineers for 9/11 Truth – DOI: <http://dx.doi.org/10.1051/eprn/2016402>

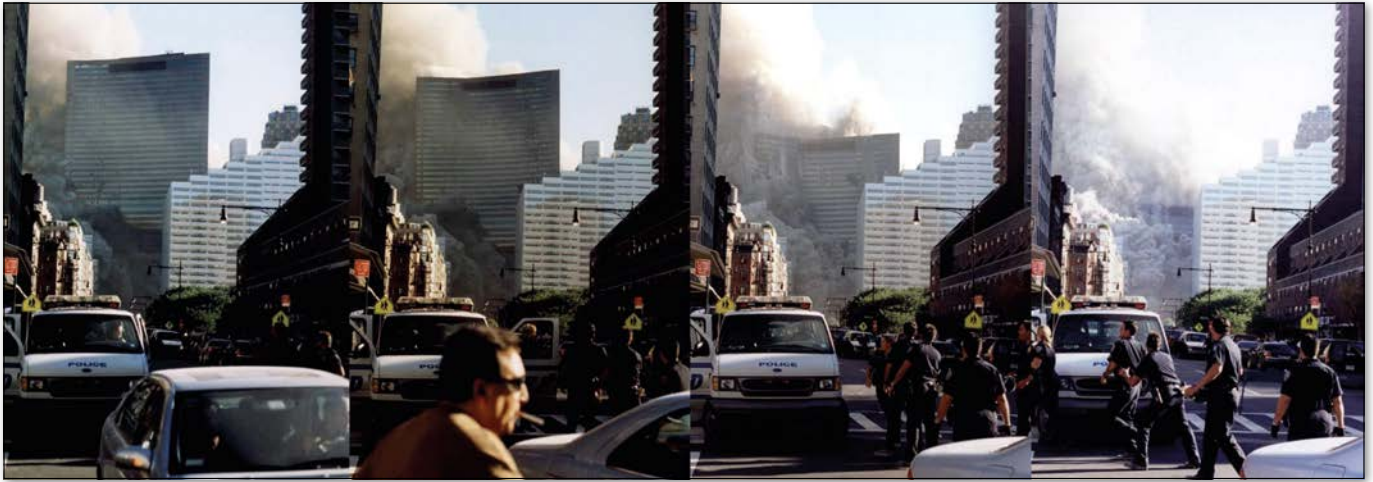
▼ FIG. 1: WTC 5 is an example of how steel-framed high-rises typically perform in large fires. It burned for over eight hours on September 11, 2001, and did not suffer a total collapse (Source: FEMA).

Throughout history, three steel-framed high-rises are known to have suffered partial collapses due to fires; none of those led to a total collapse. Countless other steel-framed high-rises have experienced large, long-lasting fires without suffering either partial or total collapse (see, for example, Fig. 1a and 1b) [1].
